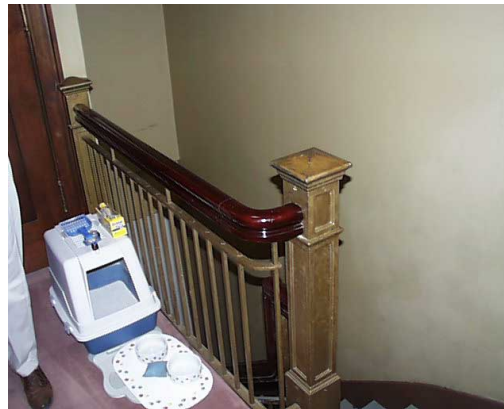
Element Code: 3.B.2 **Description:** Newel Post Abacus

Color Notes: Munsell Color Notation 7.5YR 7/4
Medium Light Brown

Findings: Found 5 layers of pigmented paint

Test/Analysis: 1st Coat – Black Primer
 1st Pigmented Layer – 7.5YR 7/4
 Medium Light Brown

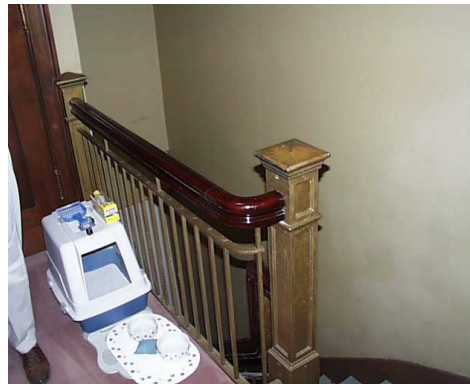
Element Code: <u>3.B.4</u>	Description: Newel Post Architrave
--	--

Color Notes: Munsell Color Notation 7.5YR 7/4
Medium Light Brown
Gold Metallic Powder

Findings: Found 5 layers of pigmented paint

Test/Analysis: 1st Coat – Black Primer
(ground) 1st Pigmented Layer – 7.5YR 7/4
Medium Light Brown
2nd Pigmented Layer – Gold Metallic Powder

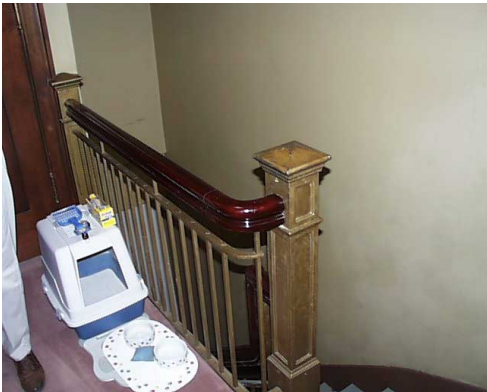
Element Code: 3.B.6 **Description:** Base of Newel Post

Color Notes: Munsell Color Notation 10YR 7.5/2
 Light Gray Brown
 Gold Metallic Powder

Findings: Found 4 layers of pigmented paint

Test/Analysis: 1st Coat – Black Primer
 (ground) 1st Pigmented Layer – 10YR 7.5/2
 Light Gray Brown
 2nd Pigmented Layer – Gold Metallic Powder

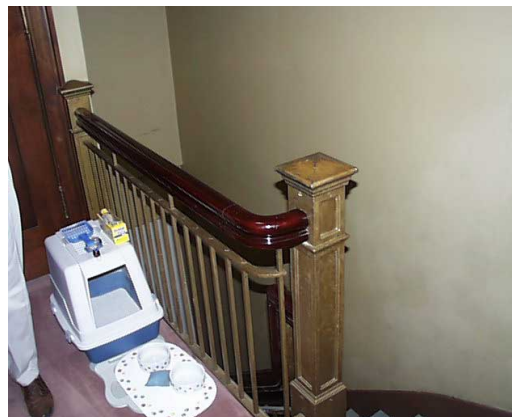
Element Code: 3.B.8 **Description:** Lower Base

Color Notes: Munsell Color Notation 10YR 7.5/2
 Light Gray Brown

Findings: Found 4 layers of pigmented paint

Test/Analysis: 1st Coat – Black Primer
 (ground) 1st Pigmented Layer – 10YR 7.5/2
 Light Gray Brown
 2nd Pigmented Layer – Gold Metallic Powder

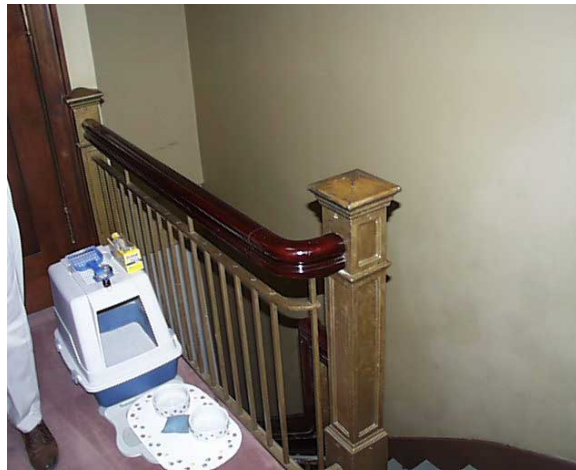
Element Code: 3.B.10 **Description:** Railing

Color Notes: Munsell Color Notation 10YR 7.5/2
Light Gray Brown

Findings: Found 5 layers of pigmented paint

Test/Analysis: 1st Coat – Black Primer
1st Pigmented Layer – 10YR 7.5/2
Light Gray Brown

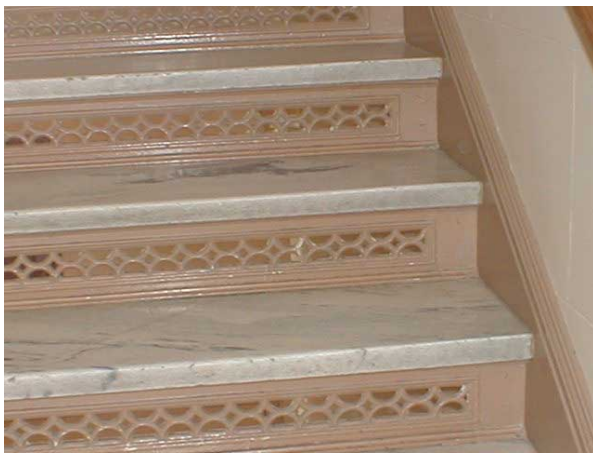
Element Code: 3.B.11 **Description:** Risers

Color Notes: Gold Metallic Powder

Findings: Found 3 layers of pigmented paint

Test/Analysis: 1st Coat – Black Primer
 1st Pigmented Layer – Gold Metallic Powder

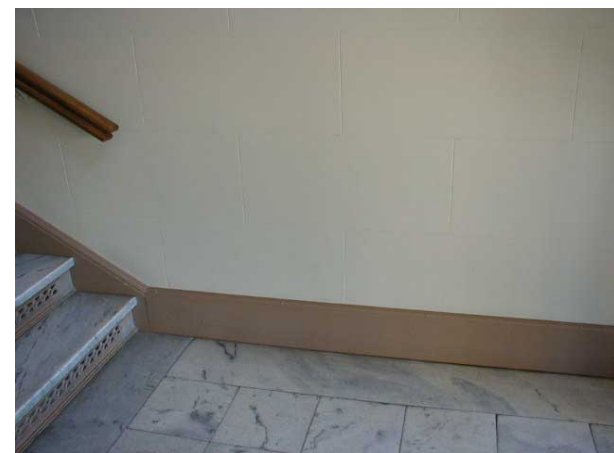
Element Code: 3.B.12 **Description:** Baseboards

Color Notes: 10YR 9/1 Gray Yellow White

Findings: Found 8 layers of pigmented paint

Test/Analysis: 1st Coat – Red Oxide Primer
 1st Pigmented Layer – 10YR 9/1
 Gray Yellow White

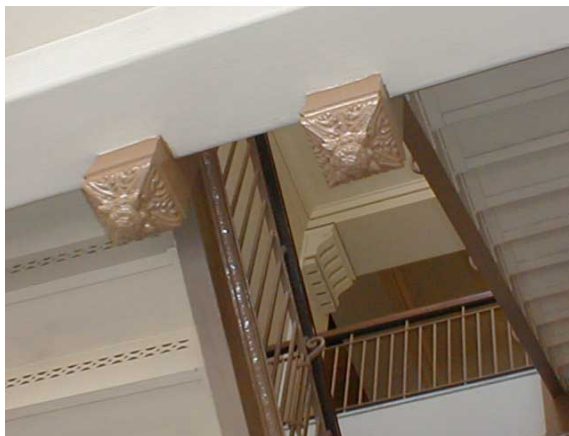
Element Code: 3.B.13 **Description:** Rosette On Stringer

Color Notes: Gold Metallic Powder

Findings: Found 3 layers of pigmented paint

Test/Analysis: 1st Coat – Black Primer
 1st Pigmented Layer – Gold Metallic Powder

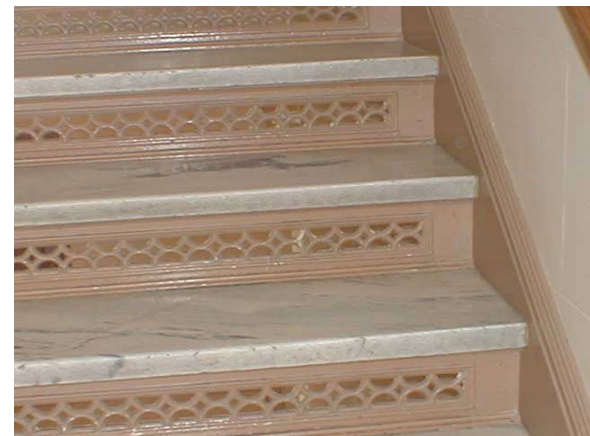
Element Code: 3.B.14 **Description:** Flat Field of String Course

Color Notes: Gold Metallic Powder

Findings: Found 3 layers of pigmented paint

Test/Analysis: 1st Coat – Black Primer
 1st Pigmented Layer – Gold Metallic Powder

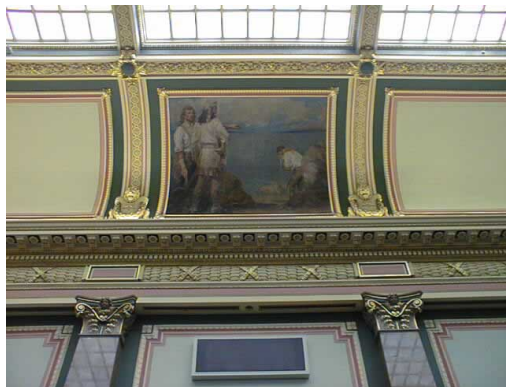
Element Code: 3.H.1 **Description:** Wall

Color Notes: Munsell Color Notation 2.5Y 8.5/2
Medium Yellow Gray

Findings: Found 6 layers of pigmented paint

Test/Analysis: 1st Coat – Orange Shellac
1st Pigmented Layer – 2.5Y 8.5/2
Medium Yellow Gray

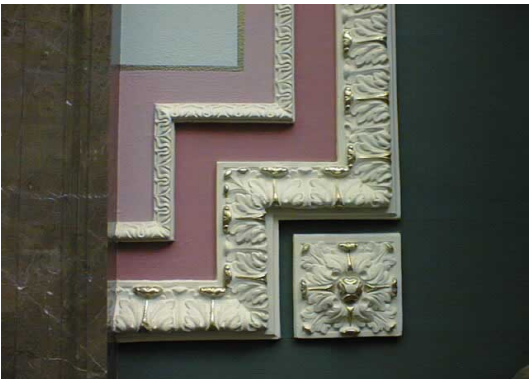
Element Code: 3.H.2 **Description:** ¼” Flat Band On Wall

Color Notes: Munsell Color Notation 10Y 6/4
Medium Dark Terra Verte
Aluminum Powder

Findings: Found 4 layers of pigmented paint

Test/Analysis: 1st Coat – Orange Shellac
(ground) 1st Pigmented Layer – 10Y 6/4
Medium Dark Terra Verte
2nd Pigmented Layer – Aluminum Powder

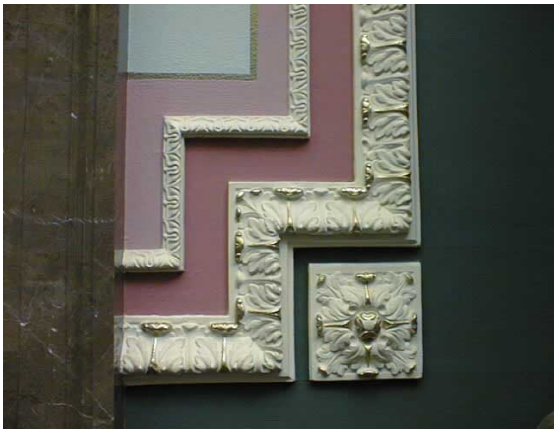
Element Code: 3.H.4 **Description:** 1” Leaf & Dart

Color Notes: Munsell Color Notation 10YR 7/8
Yellow Ochre
Gold Leaf

Findings: Found 2 layers of pigmented paint

Test/Analysis: 1st Coat – White Primer
(ground) 1st Pigmented Layer – 10YR 7/8
Yellow Ochre
2nd Pigmented Layer – Gold Leaf

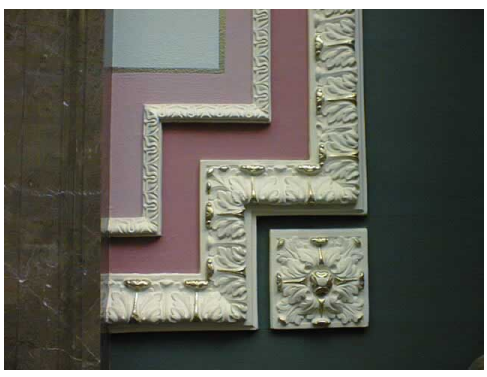
Element Code: 3.H.6 **Description:** 3” Leaf Ornamental

Color Notes: Munsell Color Notation 10YR 7/8
Yellow Ochre
Gold Leaf

Findings: Found 4 layers of pigmented paint

Test/Analysis: 1st Coat – Orange Shellac
(ground) 1st Pigmented Layer – 10YR 7/8
Yellow Ochre
2nd Pigmented Layer – Gold Leaf

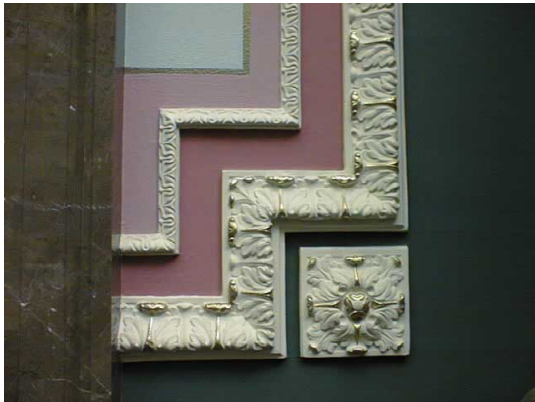
Element Code: 3.H.7 **Description:** 3” Leaf Ornament Highlighted Area

Color Notes: Munsell Color Notation 10YR 7/8
Yellow Ochre Gold Metallic Powder

Findings: Found 5 layers of pigmented paint

Test/Analysis: 1st Coat – Orange Shellac (ground) 1st Pigmented Layer – 10YR 7/8
Yellow Ochre 2nd Pigmented Layer – Gold Metallic Powder

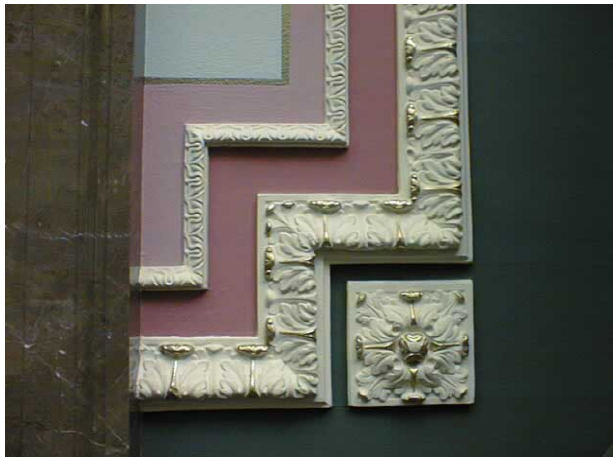
Element Code: 3.H.10 **Description:** Medallion Center

Color Notes: Munsell color Notation 10YR 7/8
Yellow Ochre
Gold Leaf

Findings: Found 4 layers of pigmented paint

Test/Analysis: 1st Coat – Orange Shellac
(ground) 1st Pigmented Layer – 10YR 7/8
Yellow Ochre
2nd Pigmented Layer – Gold Leaf

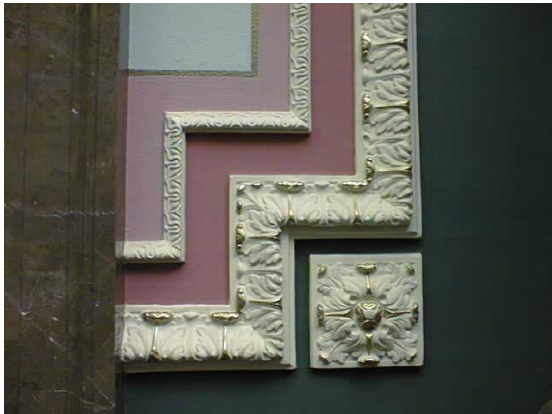
Element Code: 3.H.11 **Description:** Medallion Petals

Color Notes: Gold Metallic Powder

Findings: Found 3 layers of pigmented paint

Test/Analysis: 1st Coat – Orange Shellac
1st Pigmented Layer – Gold Metallic Powder

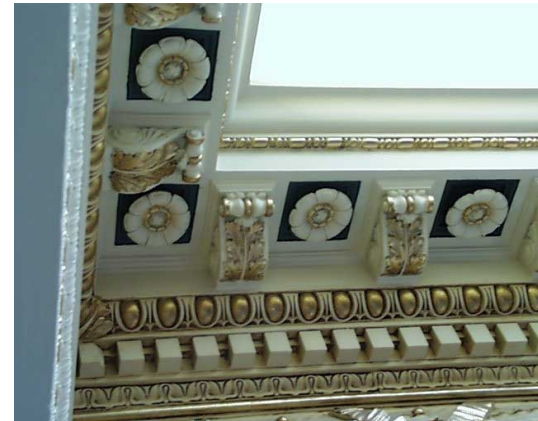
Element Code: 3.H.39 **Description:** 1 ½” Band of Crown Molding of Cornice

Color Notes: Munsell Color Notation 5Y 9/2.5
Gray Green Yellow

Findings: Found 3 layers of pigmented paint

Test/Analysis: 1st Coat – No Visible Primer
1st Pigmented Layer – 5Y 9/2.5
Gray Green Yellow

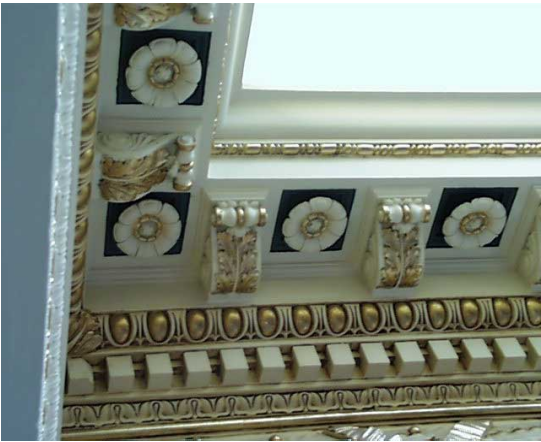
Element Code: 3.H.42 **Description:** Bead & Reel
Of Cornice

Color Notes: Gold Metallic Powder

Findings: Found 5 layers of pigmented paint

Test/Analysis: 1st Coat – No Visible Primer
1st Pigmented Layer – Gold Metallic Powder

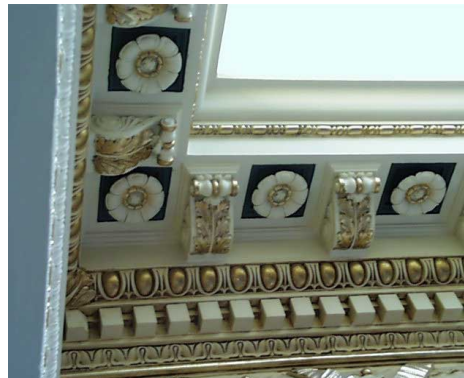
Element Code: 3.H.60 **Description:** Dentil
Molding of Cornice

Color Notes: Munsell Color Notation 5Y 9/0.5
Pale Yellow Gray
Gold Metallic Powder

Findings: Found 4 layers of pigmented paint

Test/Analysis: 1st Coat – Orange Shellac
(ground) 1st Pigmented Layer – 5Y 9/0.5
Pale Yellow Gray
2nd Pigmented Layer Gold Metallic Powder

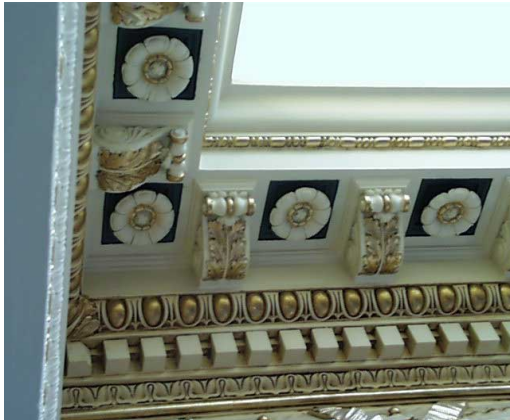
Element Code: 3.H.61 **Description:** Trim Molding
Under Dentil

Color Notes: Munsell Color Notation 10YR 8.5/1.5
Light Gray Brown White
Gold Metallic Powder

Findings: Found 4 layers of pigmented paint

Test/Analysis: 1st Coat – White Primer
(ground) 1st Pigmented Layer – 10YR 8.5/1.5
Light Gray Brown White
2nd Pigmented Layer – Gold Metallic Powder

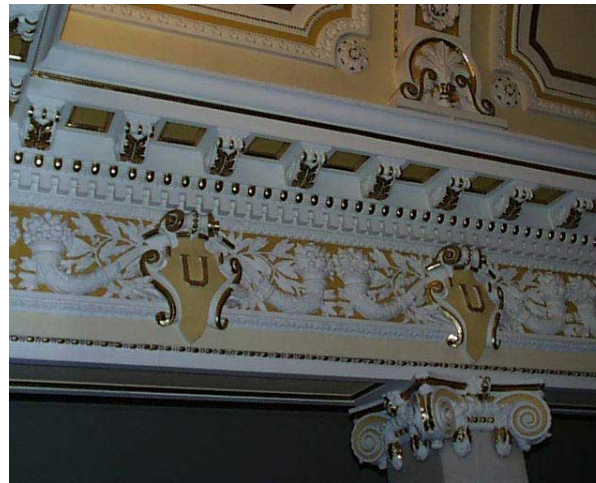
Element Code: 4.E.2 **Description:** Bead & Reel

Color Notes: Munsell Color Notation 5Y 8.5/0.5
 Yellow White Gray

Findings: Found 5 layers of pigmented paint

Test/Analysis: 1st Coat – White Primer
 1st Pigmented Layer – 5Y 8.5/0.5
 Yellow White Gray

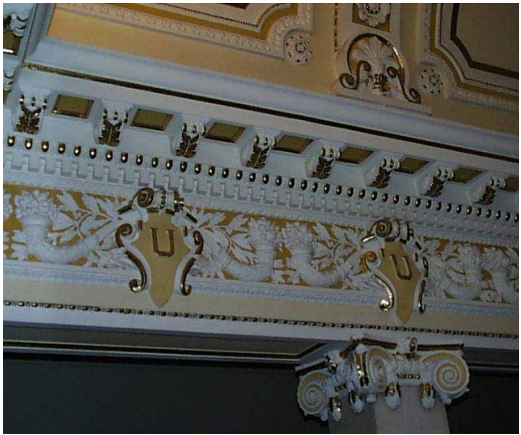
Element Code: 4.E.4 **Description:** Cornucopia

Color Notes: Munsell Color Notation 10YR 9/2
 Brown Yellow White

Findings: Found 7 layers of pigmented paint

Test/Analysis: 1st Coat – Orange Shellac
 1st Pigmented layer – 10YR 9/2
 Brown Yellow White

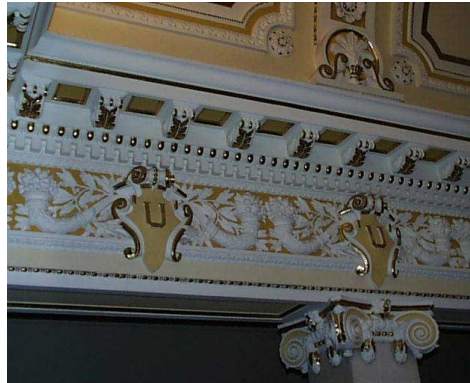
Element Code: 4.E.6 **Description:** Leaf & Dart Under Cornucopia

Color Notes: Munsell Color Notation 10YR 9/1
Gray Yellow White
Gold Metallic Powder

Findings: Found 5 layers of pigmented paint

Test/Analysis: 1st Coat – White Primer
 (ground) 1st Pigmented Layer – 10YR 9/1
 Gray Yellow White
 Gold Metallic Powder

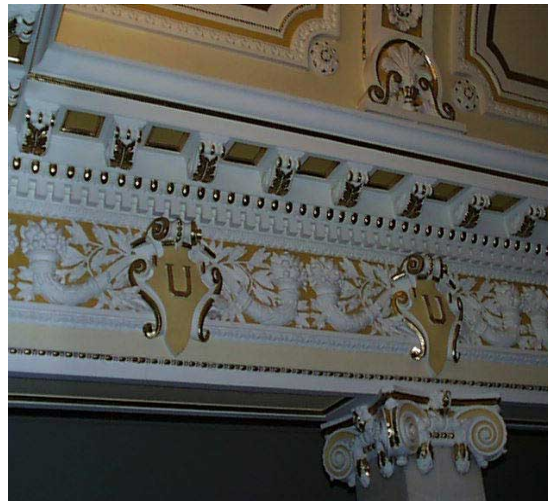
Element Code: <u>4.E.8</u>	Description: Ionic Detail Column Capital
-----------------------------------	--

Color Notes: Gold Metallic Powder

Findings: Found 4 layers of pigmented paint

Test/Analysis: 1st Coat – Orange Shellac
1st Pigmented Layer – Gold Metallic Powder

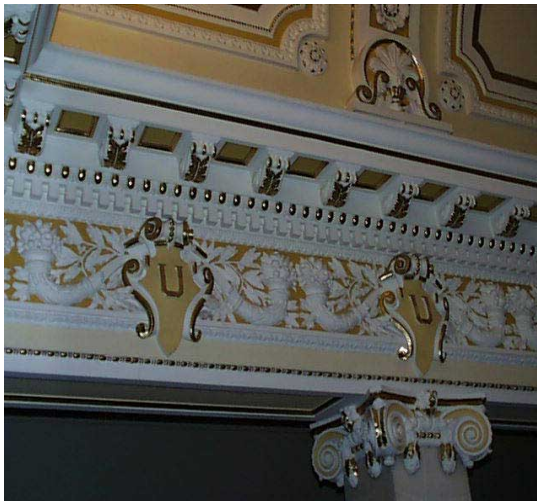
Element Code: 4.E.9 **Description:** Beam Underside

Color Notes: Munsell Color Notation 10YR 9/4
Medium Gray Brown Yellow

Findings: Found 4 layers of pigmented paint

Test/Analysis: 1st Coat – White Primer
1st Pigmented Layer – 10YR 9/4
Medium Gray Brown Yellow

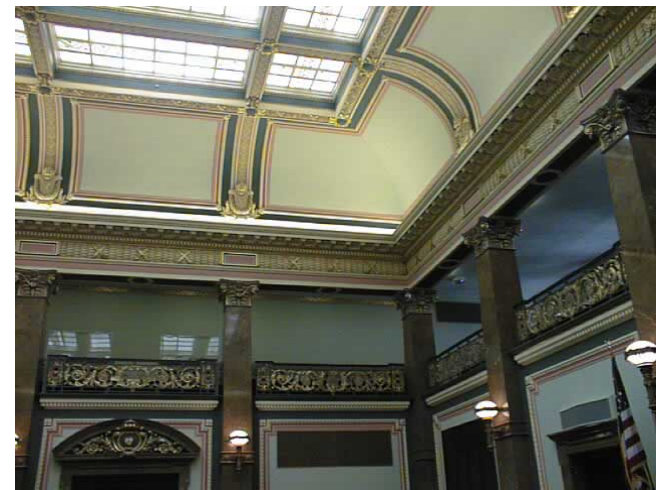
Element Code: 4.J.3 **Description:** Crown Molding

Color Notes: Munsell Color Notes 10YR 7.5/2
Light Gray Brown

Findings: Found 6 layers of pigmented paint

Test/Analysis: 1st Coat – White Primer
1st Pigmented Layer – 10YR 7.5/2
Light Gray Brown

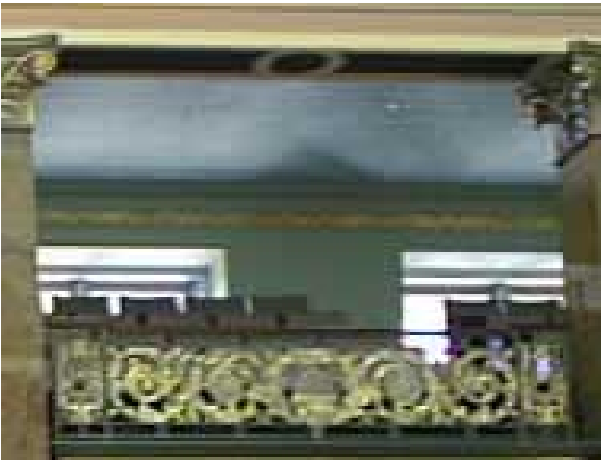
Element Code: 4.J.9 **Description:** Wall Above
Stencil Pattern

Color Notes: Munsell Color Notations 5GY 7/2.5
Medium Gray Yellow Green

Findings: Found 1 layer of pigmented paint

Test/Analysis: 1st Coat – White Primer
1st Pigmented Layer – 5GY 7/2.5
Medium Gray Yellow Green

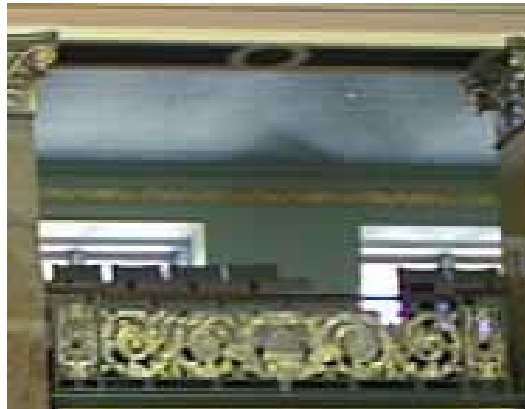
Element Code: 4.J.11 **Description:** Stencil Pattern

Color Notes: Munsell color Notation 10YR 9/2
Brown Yellow White

Findings: Found 2 layers of pigmented paint

Test/Analysis: 1st Coat – Gesso
1st Pigmented Layer – 10YR 9/2
Brown Yellow White

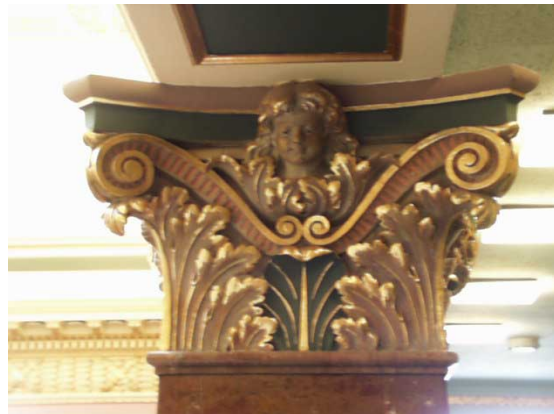
Element Code: 4.J.20 **Description:** Face on
Column Capital

Color Notes: Munsell color Notation 10YR 8/2.5
Pale Yellow Brown

Findings: Found 4 layers of pigmented paint

Test/Analysis: 1st Coat – Orange Shellac
1st Pigmented Layer – 10YR 8/2.5
Pale Yellow Brown
2nd Pigmented Layer – Gold Leaf

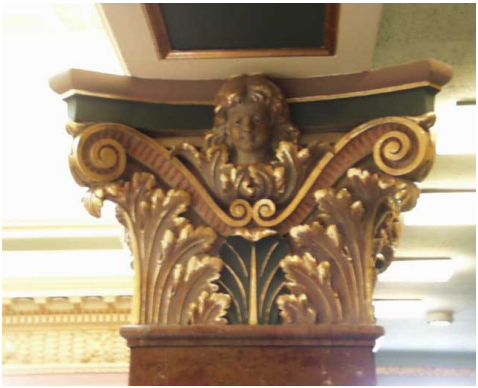
Element Code: 4.J.26 **Description:** Fluted Detail
of Column Capital

Color Notes: Munsell Color Notation 10YR 7/8
Yellow Ochre
Gold Metallic Powder

Findings: Found 4 layers of pigmented paint

Test/Analysis: 1st Coat – Orange Shellac
(ground) 1st Pigmented Layer – 10YR 7/8
Yellow Ochre
2nd Pigmented Layer - Gold Metallic Powder

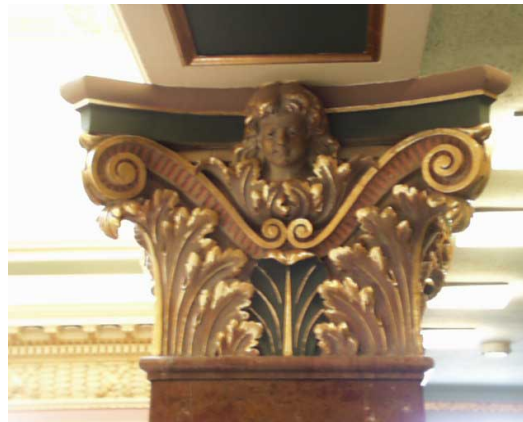
Findings: Found 3 layers of pigmented paint

Test/Analysis: 1st Coat - Orange Shellac
(ground) 1st Pigmented Layer – 10YR 7/8
Yellow Ochre
2nd Pigmented Layer – Gold Metallic Powder

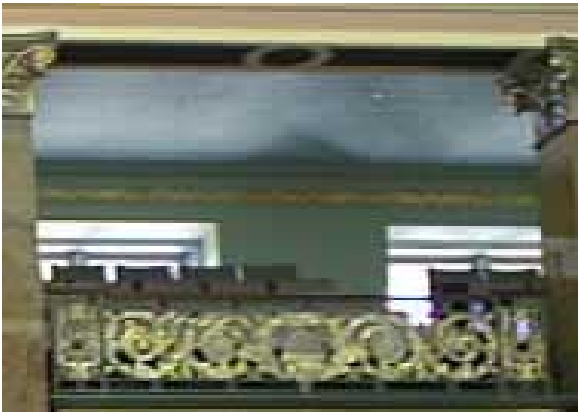
Findings: Found 5 layers of pigmented paint

Test/Analysis: 1st Coat – White Primer
 1st Pigmented Layer – 5GY 7/2.5
 Pale Yellow Green

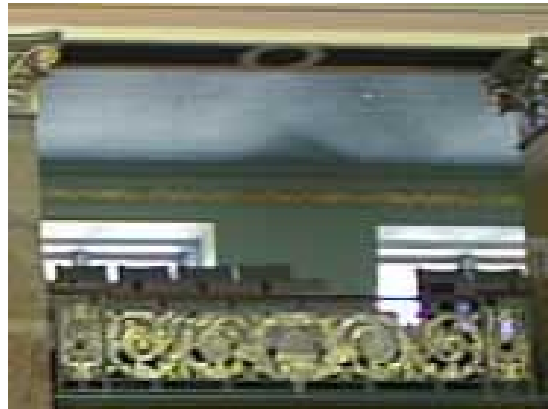
Findings: Found 7 layers of pigmented paint

Test/Analysis: 1st Coat – No Visible Primer
(ground) 1st Pigmented Layer – 10YR 7.5/2
Light Gray Brown
2nd Pigmented Layer – Gold Metallic Powder

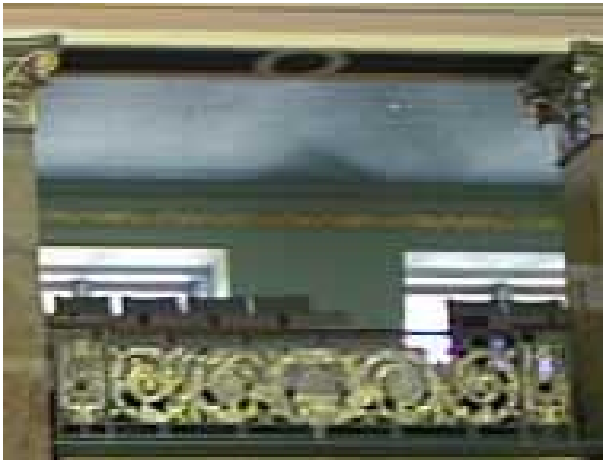
Findings: Found 4 layers of pigmented paint

Test/Analysis: 1st Coat – White Primer
1st Pigmented Layer – 10YR 7/4
Medium Dark Gray Brown
